TECHNICAL NOTE

Contract NAS8-32982 **Date** 13 July 1979 **Doc.** LMSC-HREC TN D697613

Title: SPACE SHUTTLE SRB TPS PROTECTIVE PAINT TEST AND EVALUATION
IN NASA HOT GAS FACILITY AND AEDC TUNNEL C

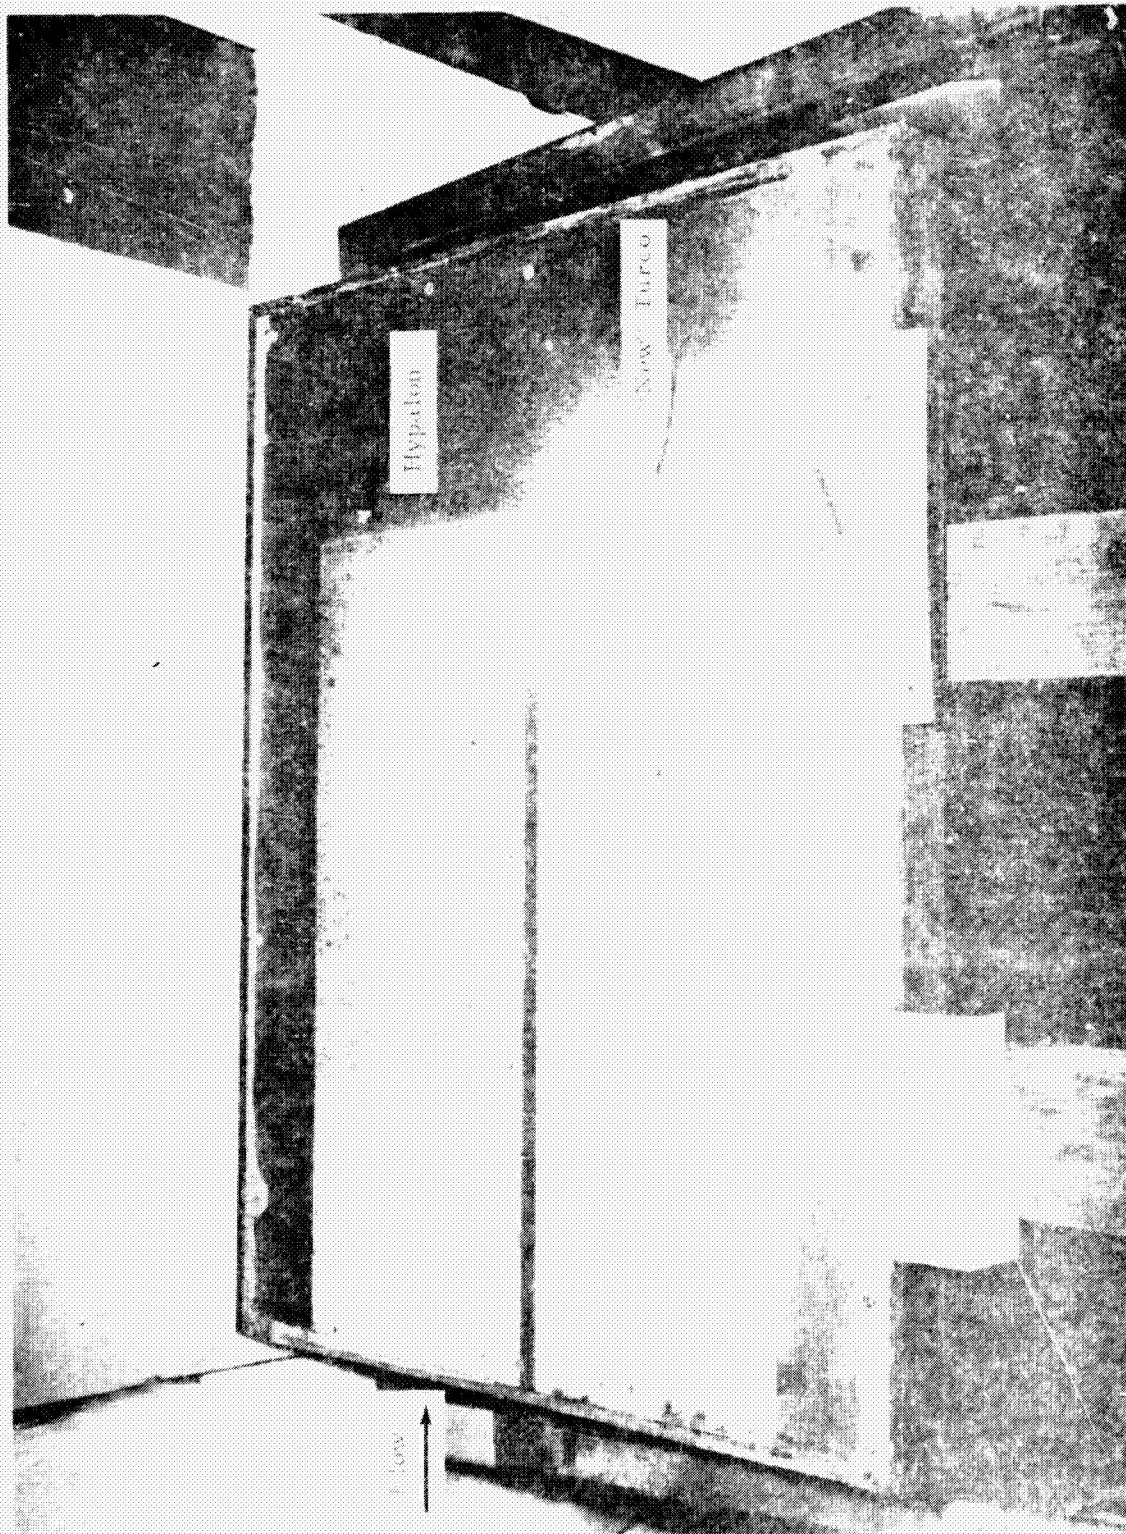
Fig. 11 - Post-Test Photograph of Hot Gas Facility Paint Panel with Hypalon on One Side and "New" Turco on the Other (The "New" Turco is seen to have melted and flowed whereas the Hypalon has not.)
